Bulletin No.	TS79-023
Date	April 9, 1979
Classification	CO79-002
Section	Cooling System
Models	All

BLOCK HEATER INSTALLATION

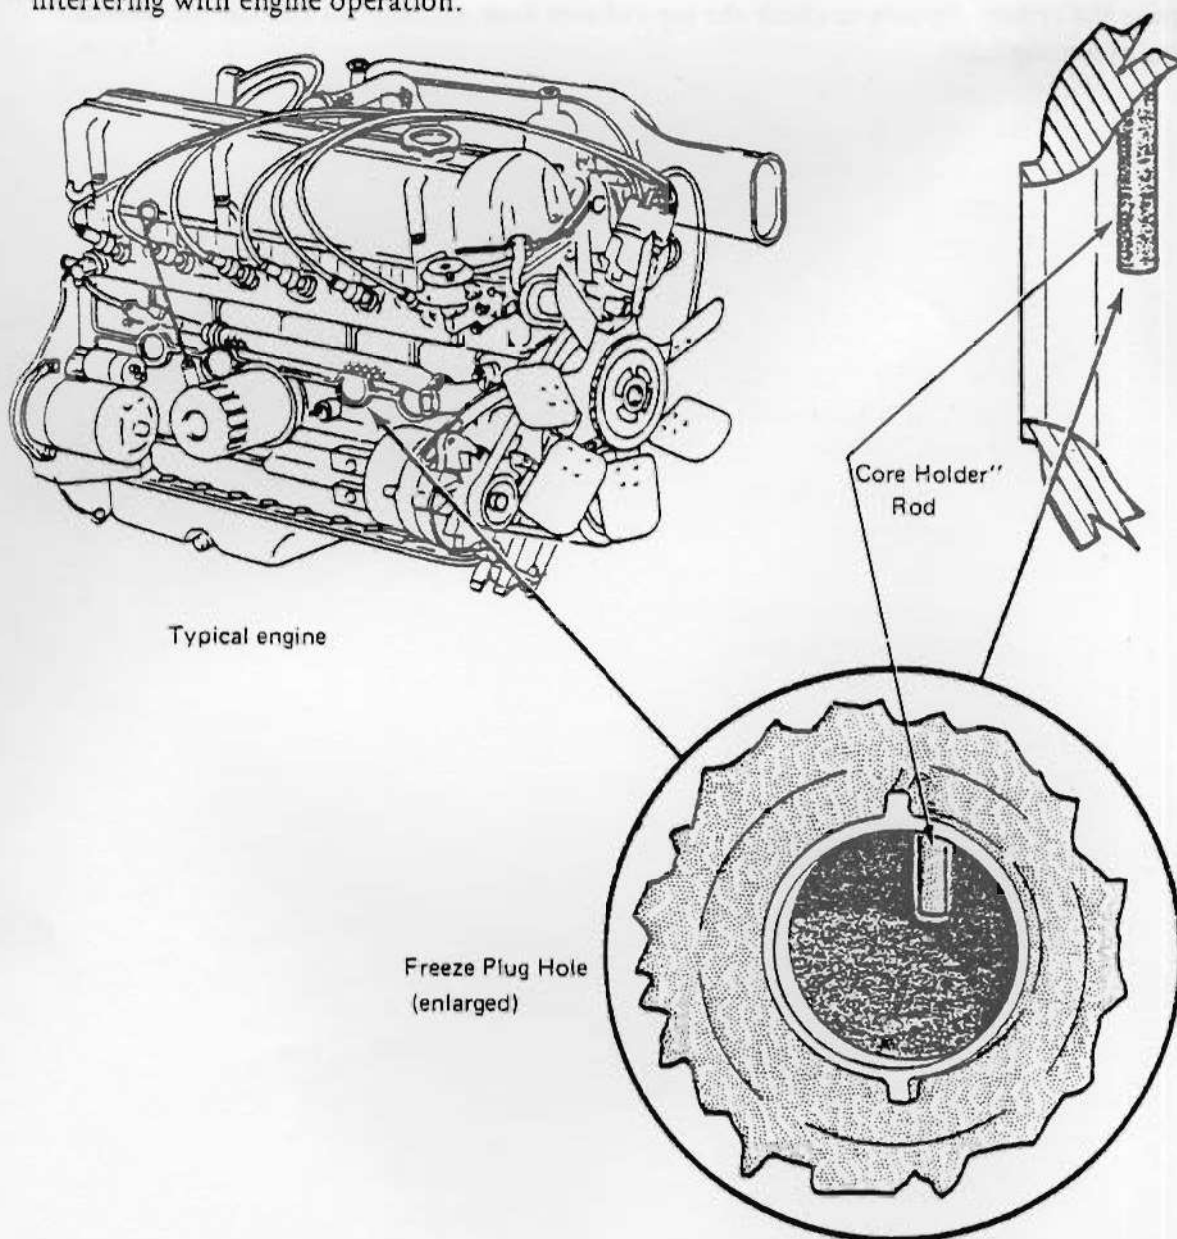
Service Information. When installing engine block heater P/N 99990-00032 or 99990-00033 in Datsun vehicles, a 3/16" diameter "core holder" rod located in the water jacket, may interfere with installing the block heater into the freeze plug hole. If the "core holder" rod interferes with the installation, the rod may be removed or bent as necessary without interfering with engine operation.
