Technical Service Bulletin # TS85112

Recall - Emissions/Ignition System modifications TS85-112

November 21, 1985

SPECIAL SERVICE CAMPAIGN 1982 280ZX NON-TURBOCHARGED

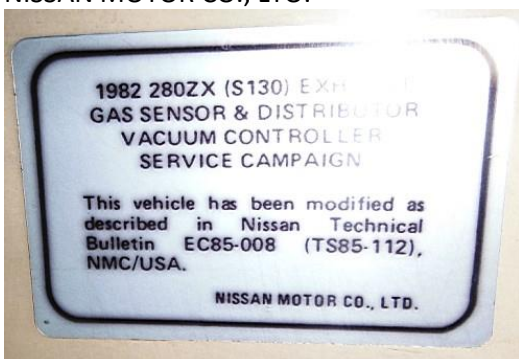
FIGURE 1

2. The dealer must install the underhood label (Figure 1) next to the existing Emission Control Information label when the correction has been completed.

- III. Install the campaign completion label next to the Emission Control Information label on the underside of the hood.
