# SERVICE BULLETIN

| WT88-003 | TS88-152 | November 21, 1988 |

## TIRE DIAGNOSTIC PROCEDURES

**APPLIED VEHICLE(S):** All Models

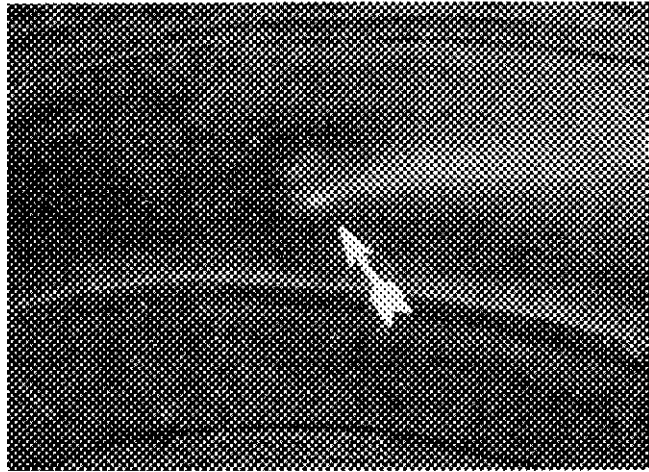
**FIGURE 1**

**DEFINITION:** A lifting of the rubber layer (i.e., portions of sidewall stock or white sidewall rubber) from the tire's sidewall structure, caused by lack of adhesion between the rubber and structure. This lifting will often 'pocket' air (see Figure 1).

1. Check for proper air pressure.
2. Localized separation, with or without an air pocket, between the sidewall rubber and tire casing.
3. There should be no evidence of chafing, shock, or abrasion on the tire sidewall.
4. There should be no tread penetrations or perforations in the tread area directly adjacent to the blister.

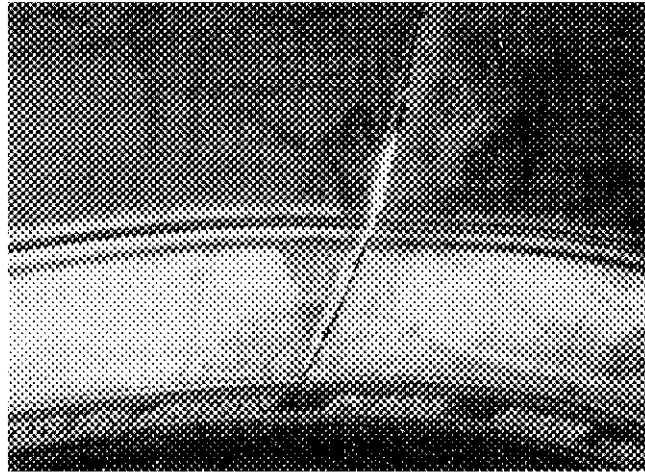
**FIGURE 2**

**DEFINITION:** A localized detachment of the rubber stock between the block and/or white sidewall, caused by a lack/loss of adhesion where the rubber stock is joined (Figure 2). An open splice may be a partial opening or a complete detachment and total perforation to the interior.

1. There should be no evidence of cuts or perforations in the failed area.
2. At the point of failure, interior rubber surfaces will be smooth and will appear joined at an angle.

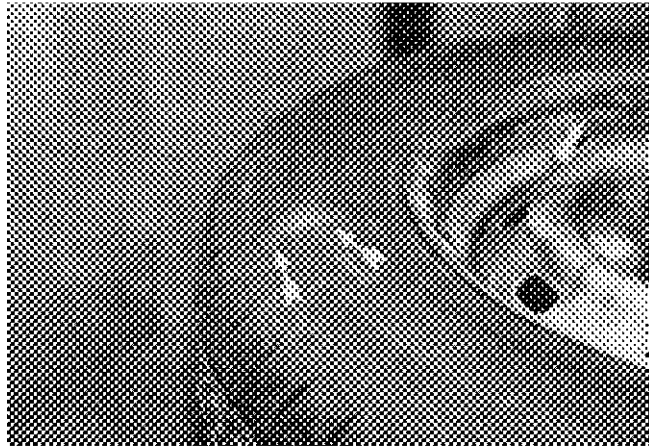
FIGURE 3

**DEFINITION:** Localized separation of the sidewall ply cord (Figure 3)

1. Check for proper air pressure.
2. Check for an air bubble on the tire sidewall.
3. There should be no signs of scuff marks, abrasions, or chafing on the immediate area (i.e., on the bubble).

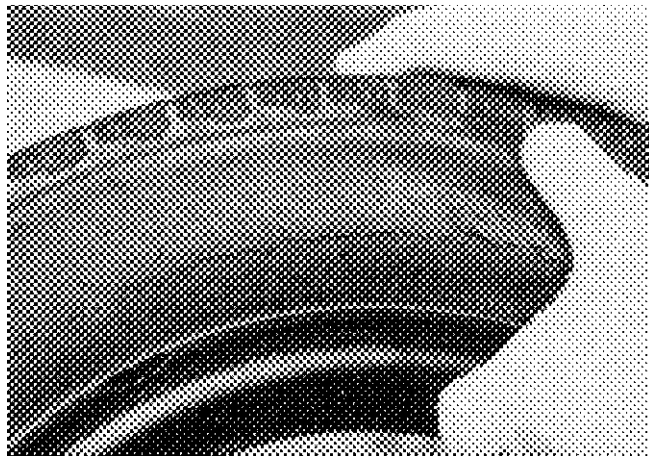
FIGURE 4

**DEFINITION:** Several fine cracks on the tire sidewall, running in a radial or circumferential direction (Figure 4).

1. Check for proper air pressure.
2. Check for several fine cracks on the sidewall, running in a lateral direction. These sidewall cracks are generally less than 1/10 of an inch in width, and do not penetrate to the interior of the tire.

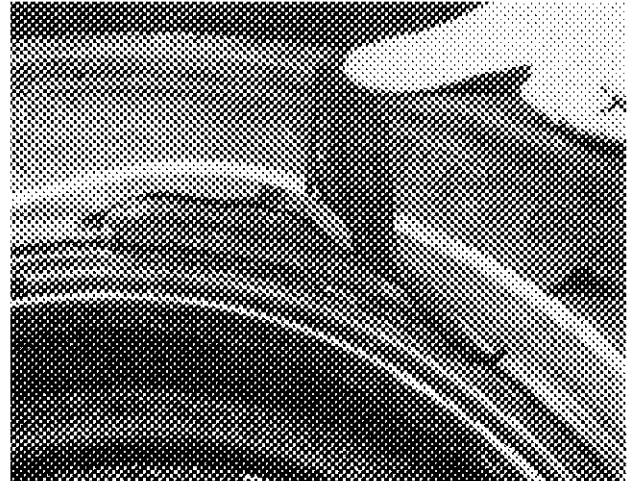
**DEFINITION:** Separation of the various tire materials (i.e., rubber, cord and wires) at the bead area near the rim line (Figures 5A, 5B).

Check for a bulge and/or jagged cracks visible near the tire rim fitting line.

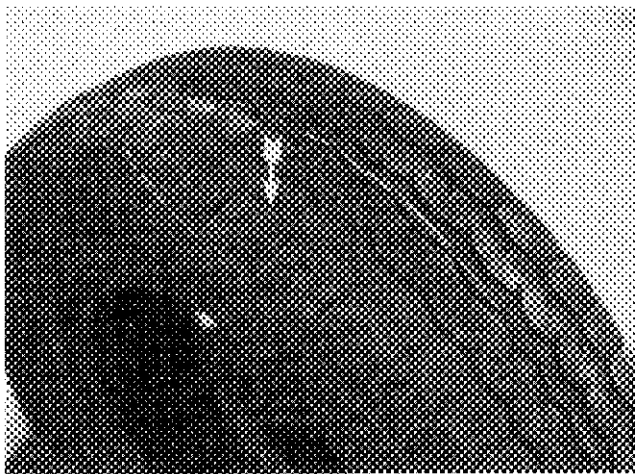
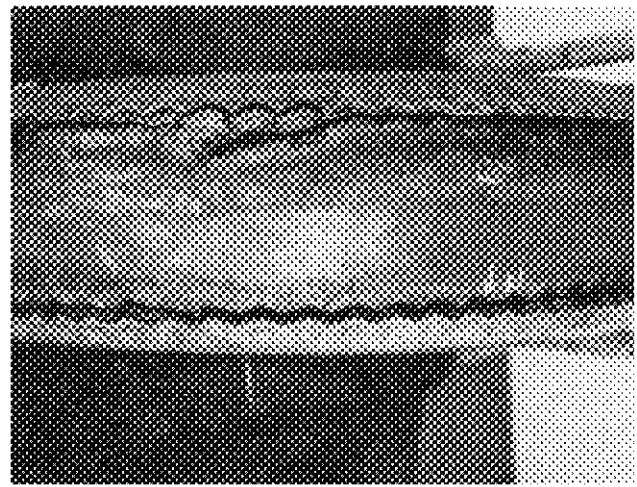
**DEFINITION:** Partial (Figure 6A) or complete (Figure 6B) separation between the rubber and the tire cord, or between the layers of the tire cord.

Check for a bulge on the tire shoulder, and a longitudinal crack on the bottom of the grooves, possibly accompanied by a break through the rubber surface. Both are usually accompanied by localized wear in the tread above the separation.

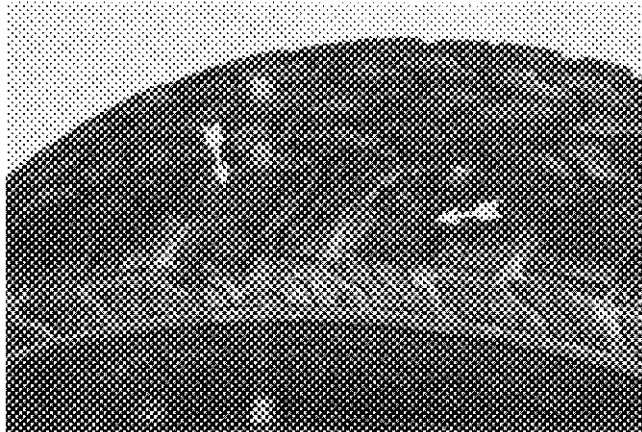
FIGURE 7

**DEFINITION:** Partial peeling of new tread (Figure 7).

Check for tearing off, partial peeling or chipping of the tire tread. (NOTE: Tread rubber chipping caused by off-road driving is not warrantable.)

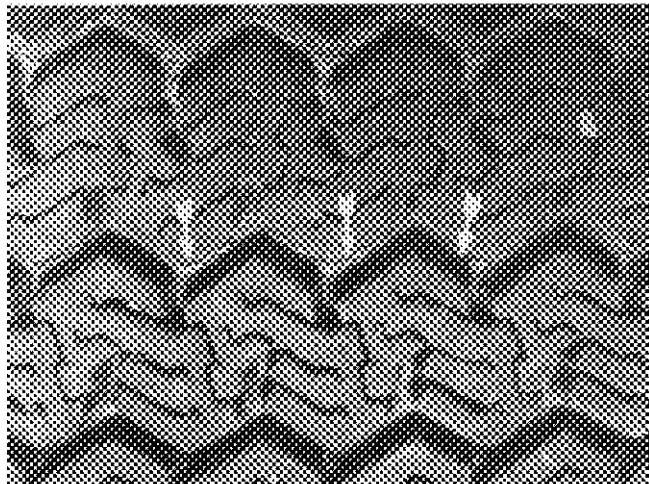
FIGURE 8

**DEFINITION:** Fine longitudinal cracks appearing on the bottom of the tire grooves which do not penetrate into the cord material of the tire (Figure 8).

Check all the vehicle tires. If there are only one or two 'cracks' in the tire groove, or if the 'crack' continues up the side of the groove wall, the cause of the 'crack' was a cut inflicted by a road hazard, and is not warrantable.

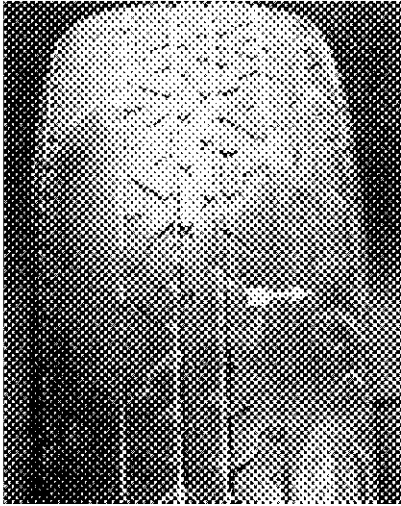
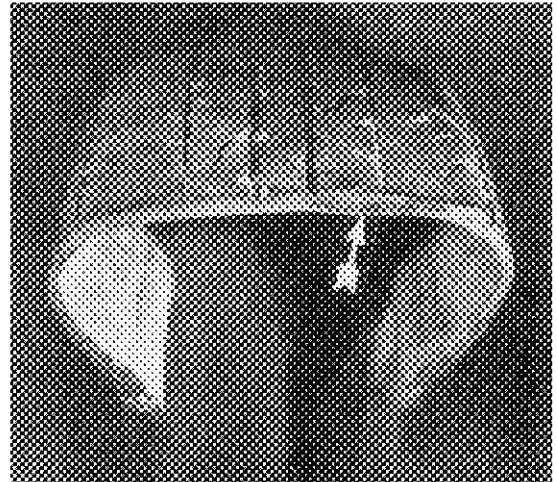
**DEFINITION:** Separation between the tread rubber and tire cord materials (Figure 9A), or between the tire cord ply layers (Figure 9B).

Check for tread separation at the tire shoulder area and the corresponding location inside the tire. There should be no evidence of accidental injury by sharp, perforating objects (e.g., screws, nails).

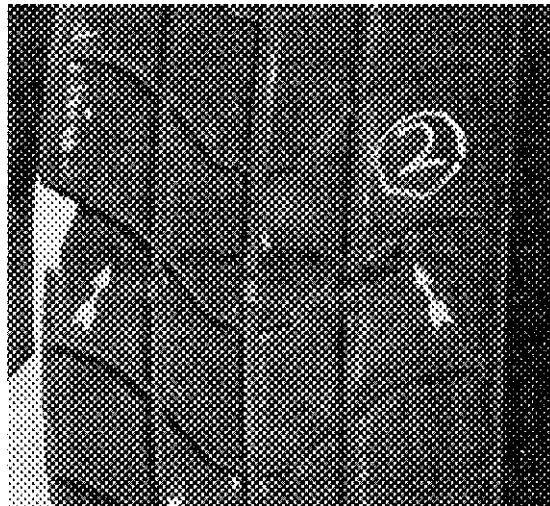
FIGURE 10

**DEFINITION:** An open area of the tire tread where the tread rubbers overlap (Figure 10).

Check the edge of the splice opening; it will have a beveled appearance. The cracks do not penetrate through the tire cord, and the possibility of air leakage does not exist.

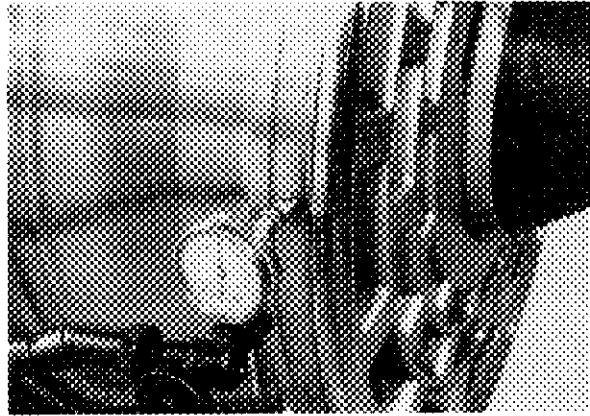
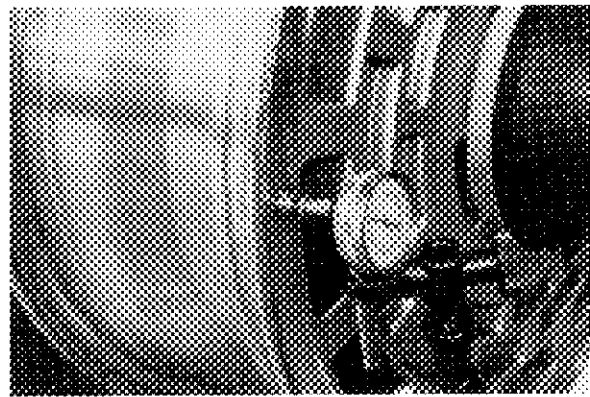
FIGURE 12A: Checking rim radial runout

FIGURE 12B: Checking rim lateral runout.

Check rim lateral and radial runout on a balance machine (Figures 12A & 12B). If excessive, replace rim. Refer to the appropriate model Service Manual for correct specifications.

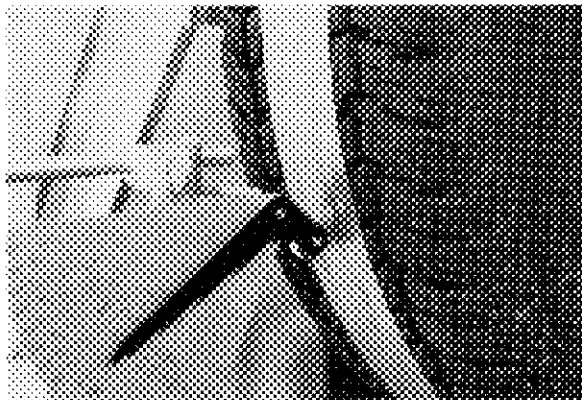
FIGURE 13: Checking tire radial runout / phase matching tire to rim.

Phase match tire to rim (Figure 13).

If tire runout is excessive, replace tire and re-check.
