SERVICE BULLETIN

POWER ANTENNA ROD REPLACEMENT

All models with power antenna

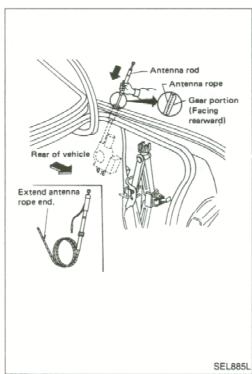
Antenna Rod Replacement

Most improper operation of the power antenna is the result of a bent antenna rod. The usual symptom of this incident is the antenna rod not going down all the way down when the radio is turned off.

1. Remove antenna nut and base.

- Turn radio "ON" and the antenna rod will extend. Assist the antenna rod to fully separate from the antenna base.
 (Note the direction of the gear section on the antenna rope. The new antenna rod must be installed in the same direction.)
- Insert replacement antenna rod with radio in "ON" position. Insert gear section of antenna rope with gear section facing the motor section assembly or as noted in Step #2.
- 4. Turn radio "OFF" to retract antenna rod. (If the antenna motor stops before the antenna has fully retracted, turn the radio switch "ON" and immediately turn it "OFF" again.) Guide the antenna rope and rod into antenna assembly.
- Reinstall the antenna nut and base. Check antenna operation by cycling radio "ON" and "OFF".
