SERVICE BULLETIN

Classification:	EL94-004	Section:	Electrical	Models:	All Models
Reference:	TECHNICAL BULLETIN NTB94-019			Date:	February 17, 1994

POWER ANTENNA ROD REPLACEMENT

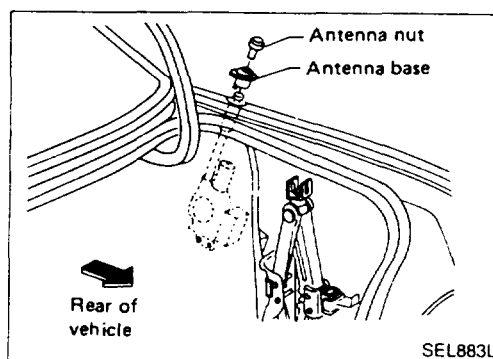
Figure 1

Improper retraction of the power antenna will usually be found to be caused by a bent antenna rod. After ensuring that the antenna motor is receiving proper power and is operational, replacement of the antenna rod is the only repair needed to restore power antenna operation.

1. Remove antenna nut and base. (Figure 1)
