Bulletin No.	TS83-086
Date	May 27, 1983
Classification	EE83-003
Section	Engine Electrical
Models	All

MOLD LINES ON DISTRIBUTOR CAPS

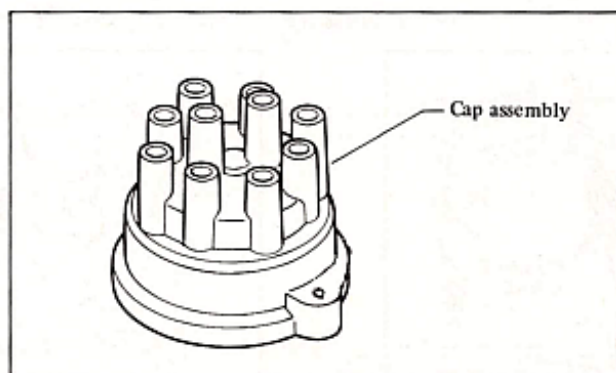
Many distributor caps, both in service and in stock, have fine, visible lines on their interior and exterior surfaces. These are mold lines produced by the bonding of flowed plastic material during the manufacturing process. These mold lines are not cracks and do not cause or contribute to any problems with the ignition system or engine performance.

Do not replace the distributor cap simply because of the presence of mold lines.
